# Exhibit A

**Re: Notice of Intent to File Citizen Suit for Violations of the Clean Water Act  
and the Resource Conservation and Recovery Act at the Maxine Mine near  
Praco, Alabama**

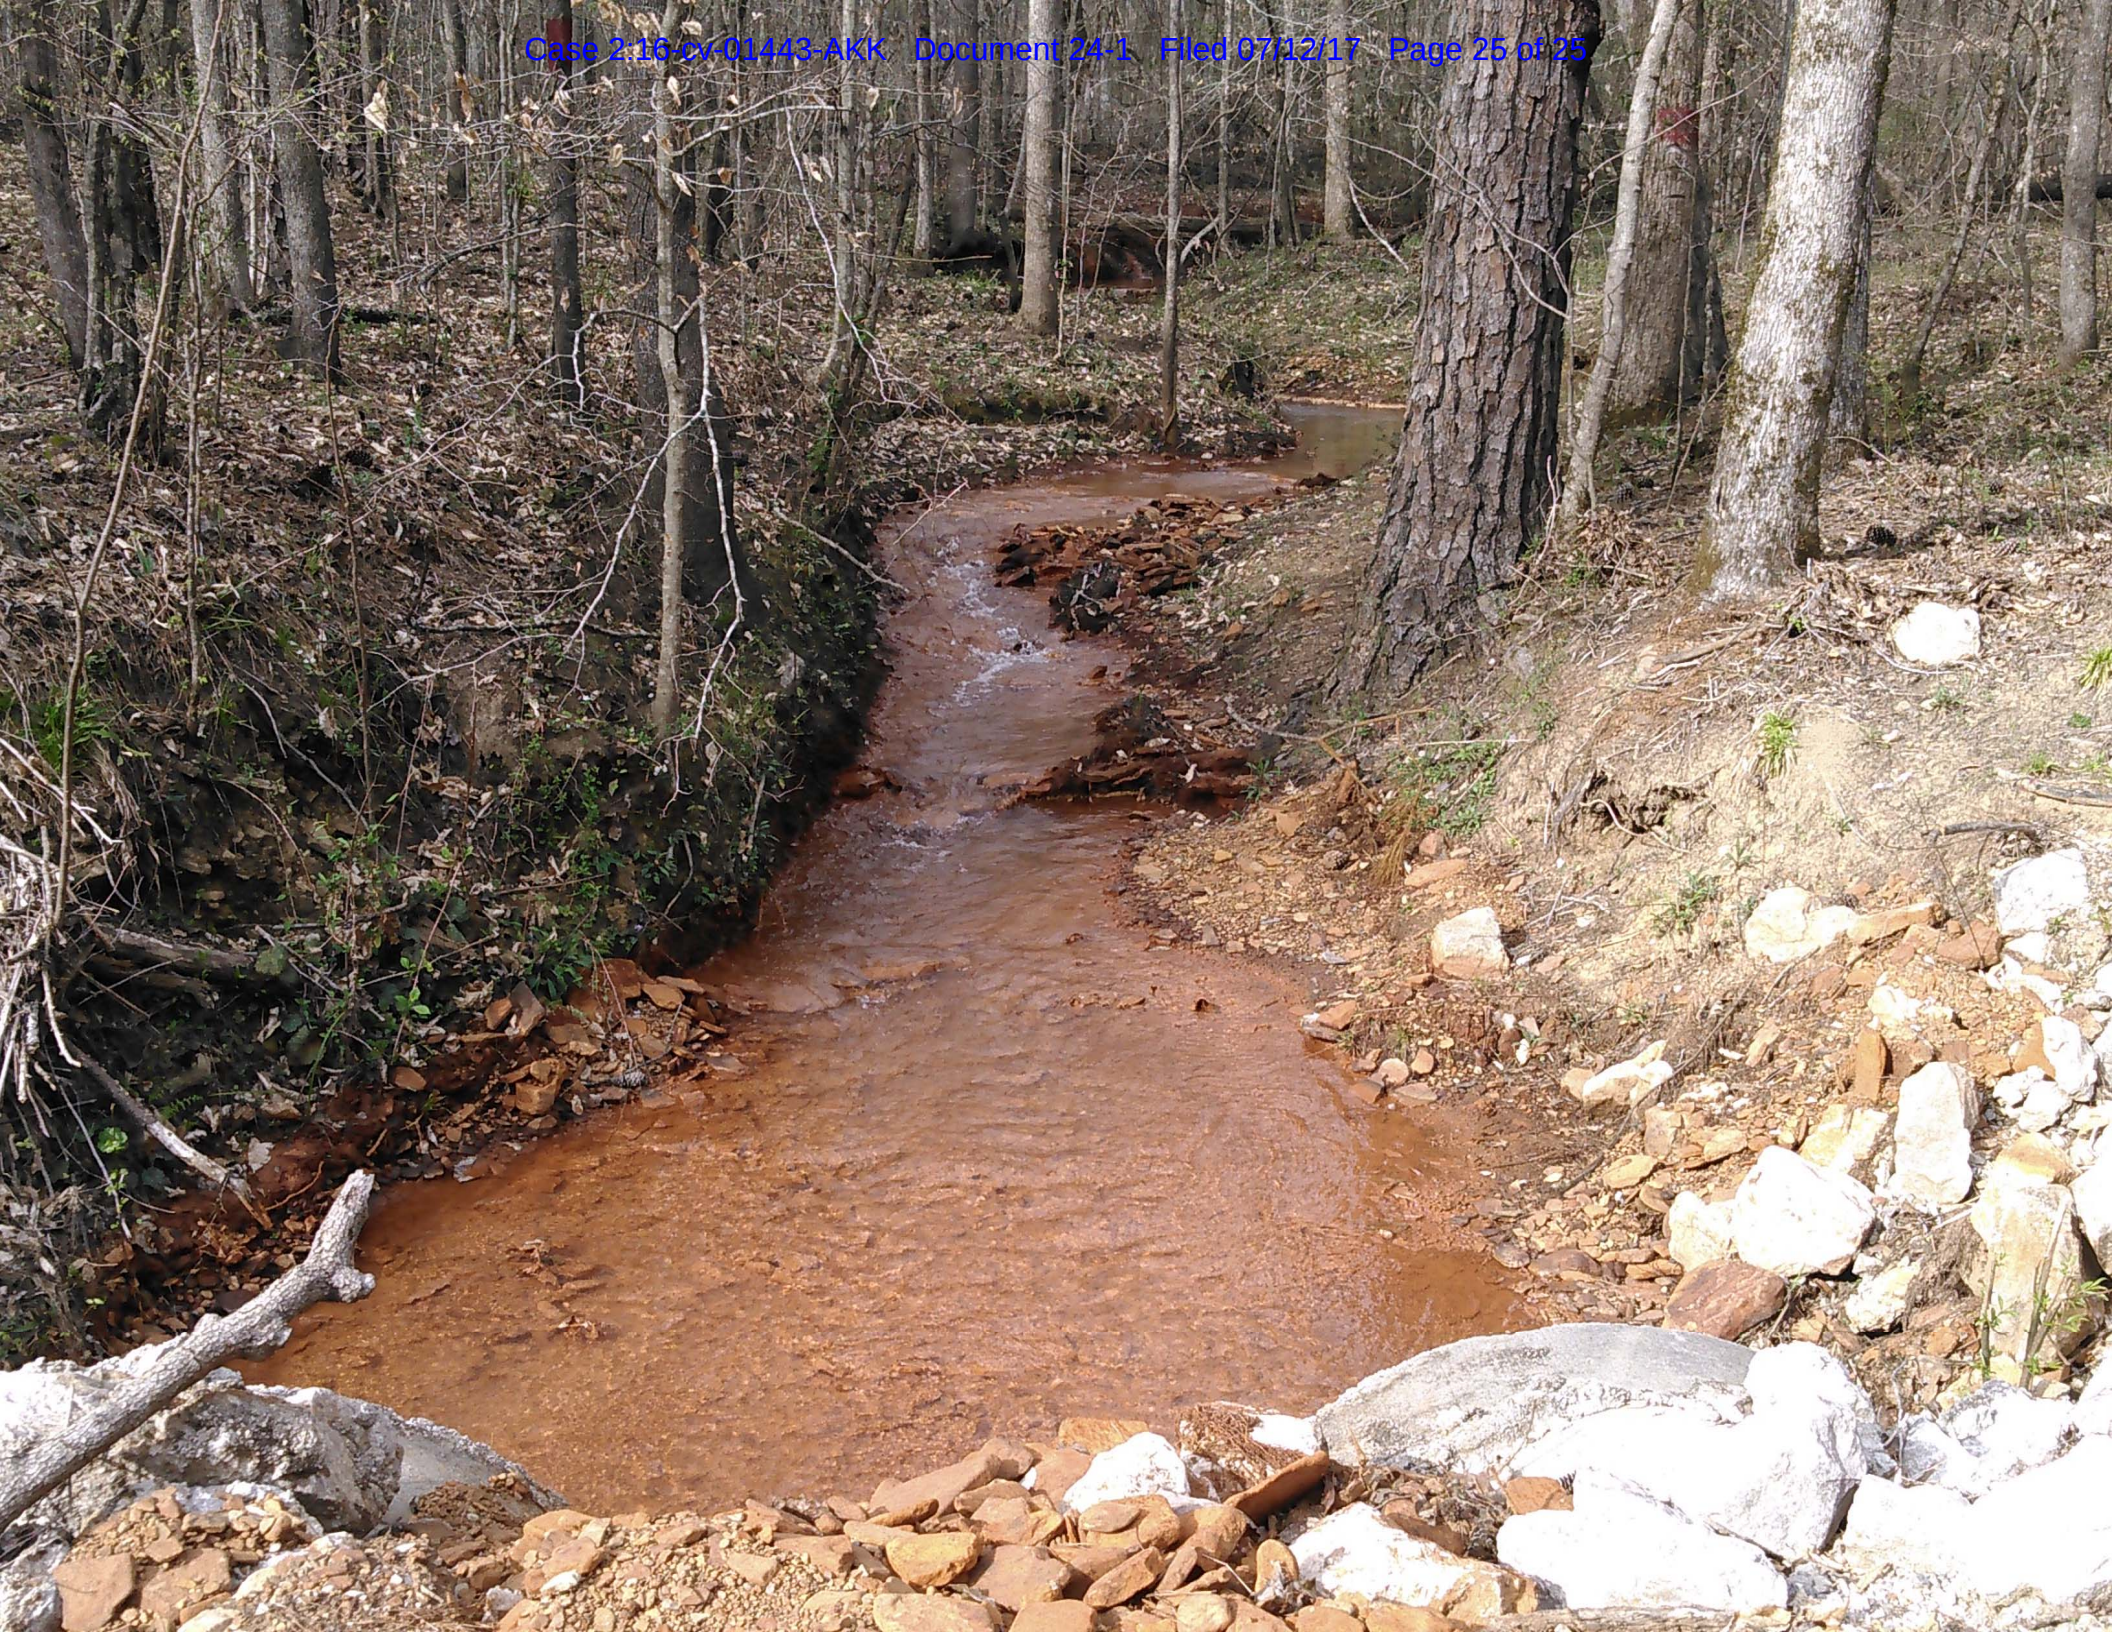
# Figure 5

In addition to the GOB pile and its related system of drainage ditches and sediment basins, the underground mine works are sufficiently “discernable, confined, and discrete” to constitute a point source under the CWA. *Beartooth Alliance*, 904 F.Supp 1168 (holding that AMD seeping from mine openings or fissures is an unpermitted discharge of pollutants from a point source). Polluted water from the mine pool is escaping the mine works and entering Brown’s Creek on a regular basis in sufficient quantities to turn the substrate of the tributary orange. (*Figure 5.*)
